City of Rockville, Maryland

College Gardens Park Stormwater Project

Photo Submittal for 2012 APWA Public Works Project of the Year

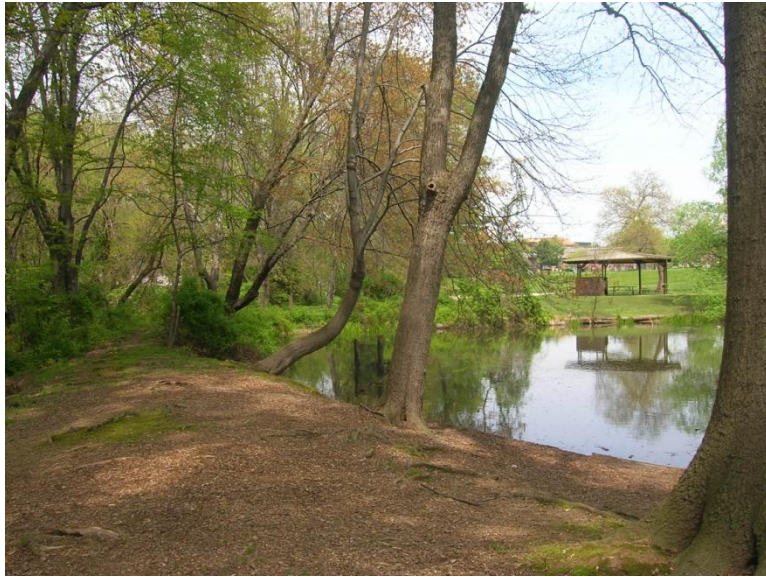
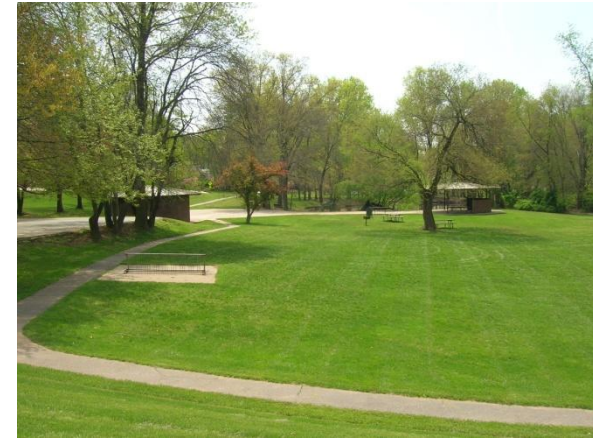
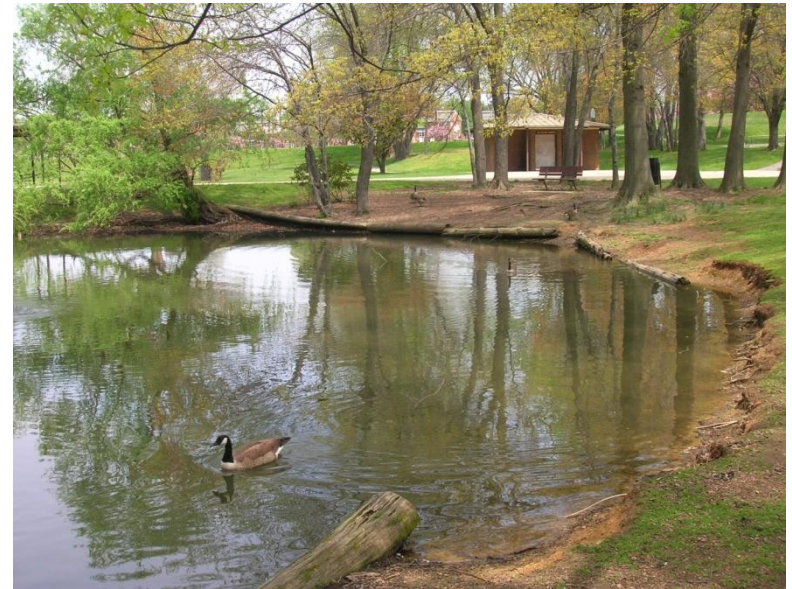
Challenges From The Original 1960s Park and Farm Pond

- No stormwater management for upstream area
- Pond level dropped during summer droughts
- Goose population degraded water quality and eroded banks
- Dam leaked and was compromised by tree roots

- Site erosion and drainage complaints
- Changing recreation demands
- Park paths were not ADA-compliant

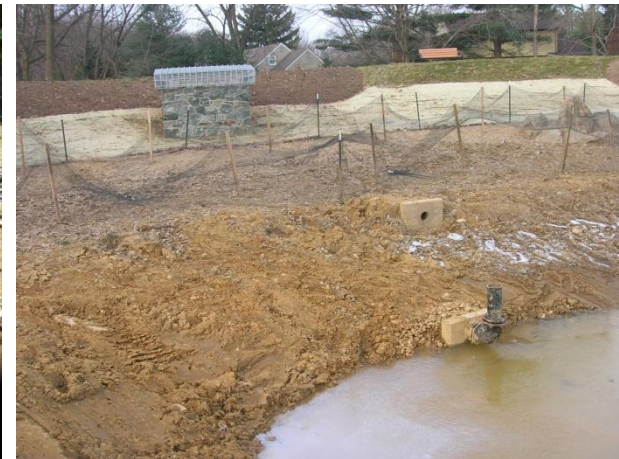
Pond Structures

Forebay Pavers and Riser,
Low Flow Pipe & Pond

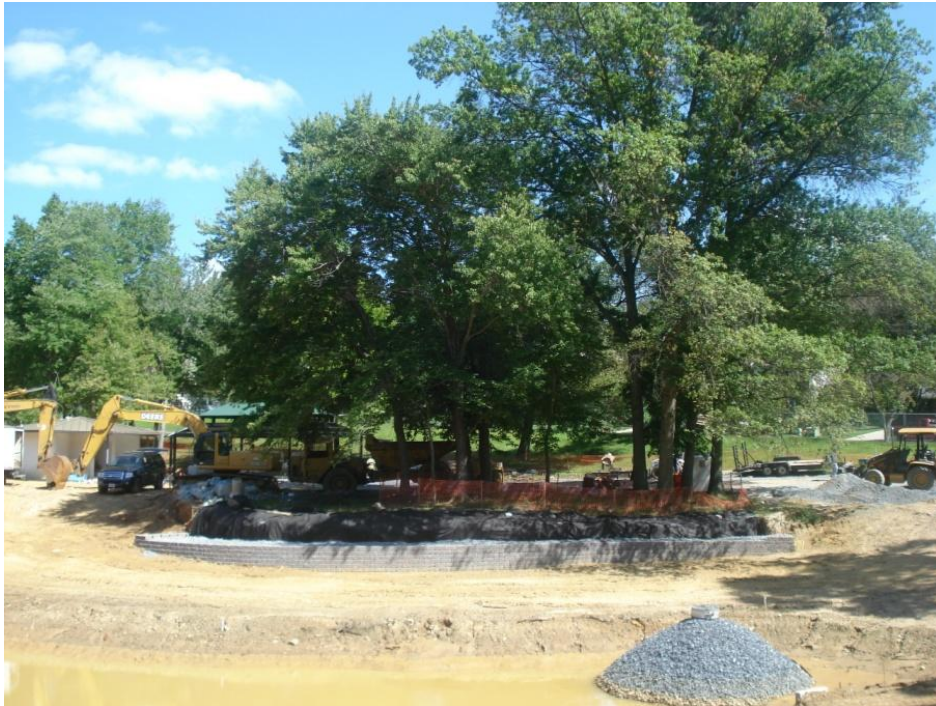
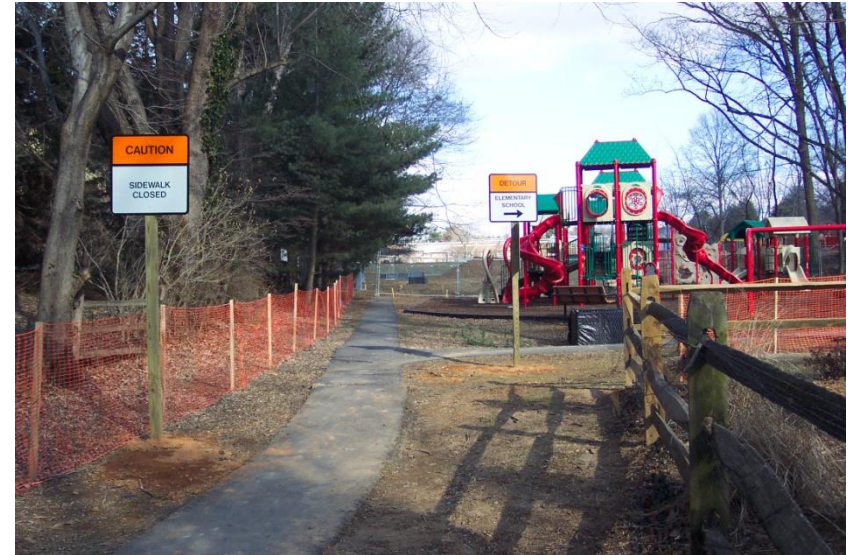
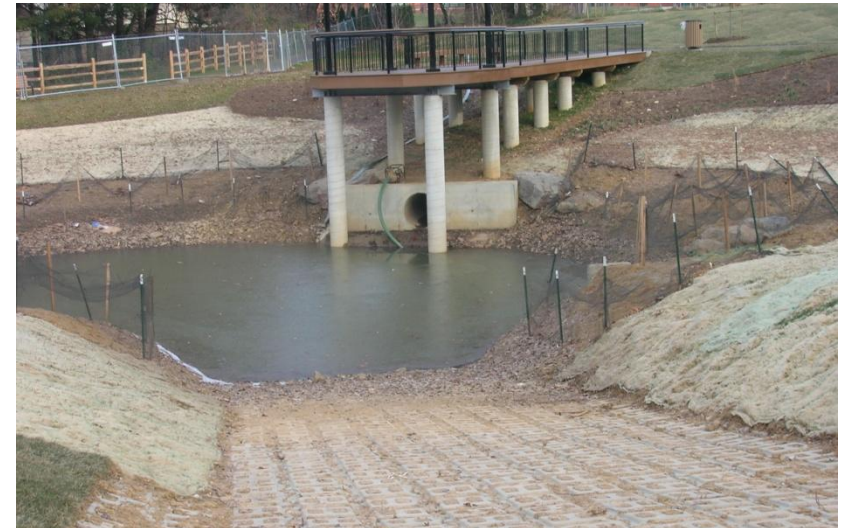
Construction Considerations

- Erosion and sediment control
- Tree preservation
- Pedestrian safety
- Future Pond Maintenance Access

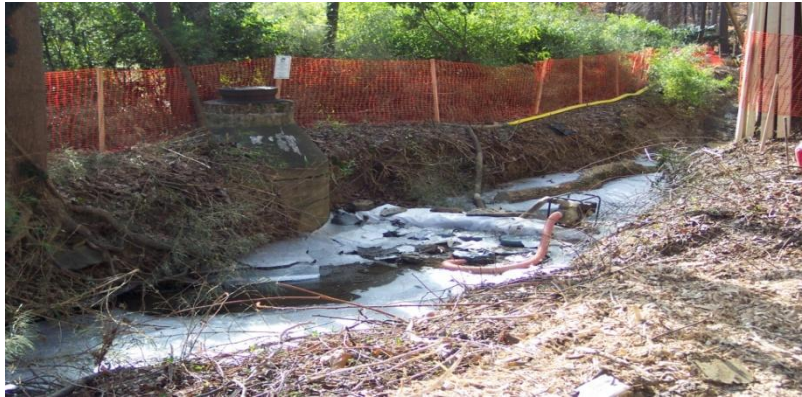
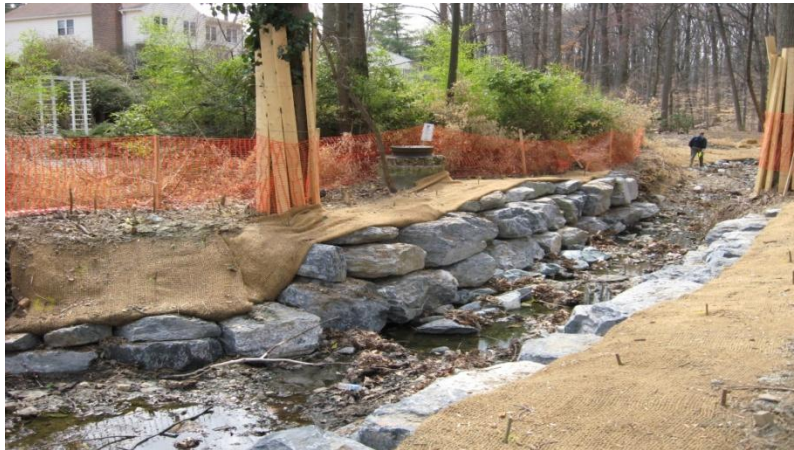
Stream Restoration: Installed 500 linear feet of stream restoration using bioengineering techniques of natural stone placement, bank reshaping and native plantings

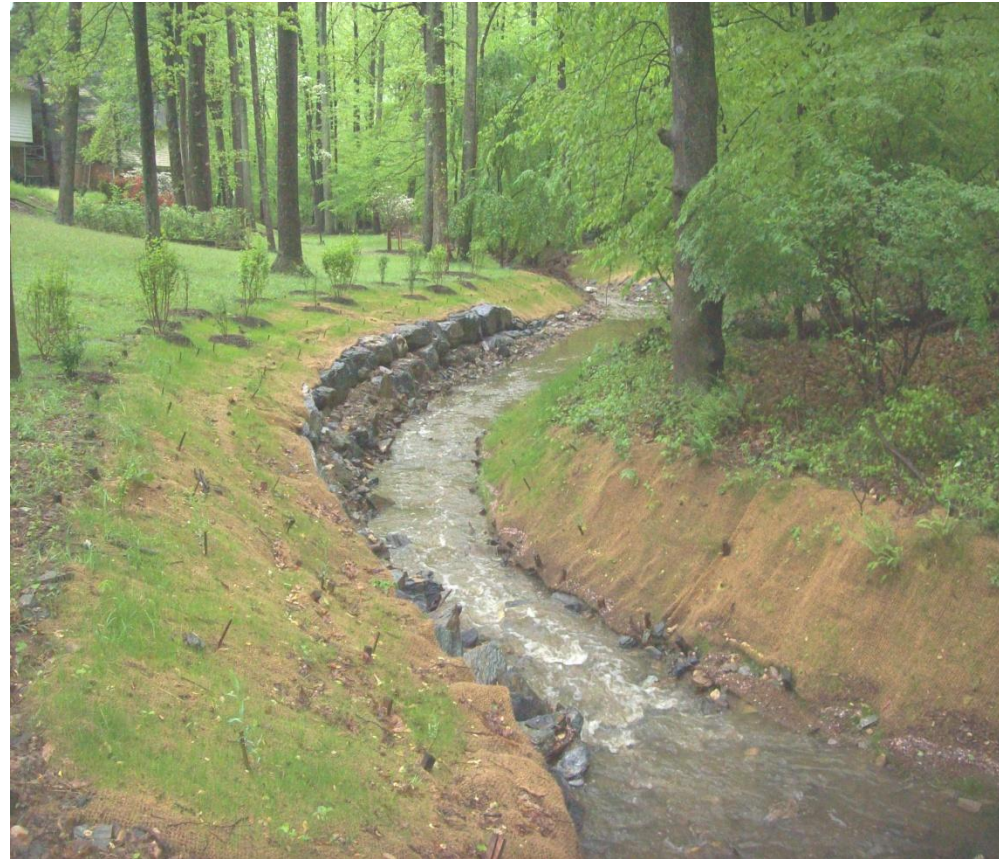
Construction

3 Months After Completion – Storm Flow

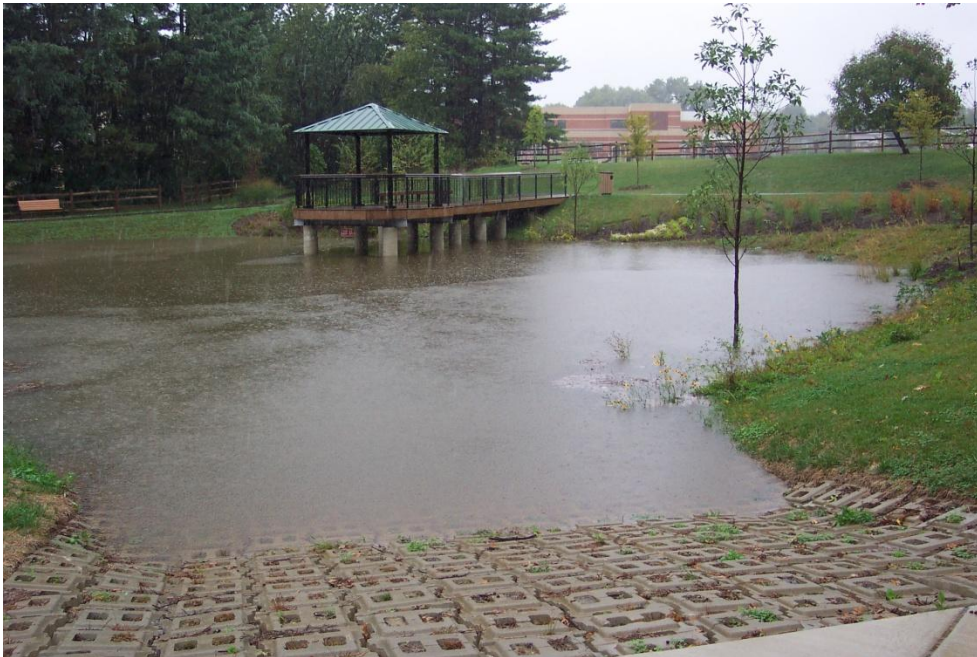
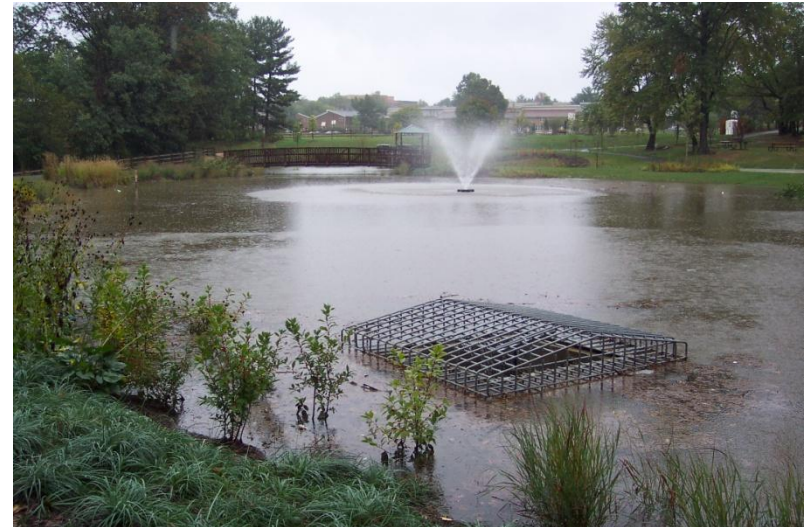
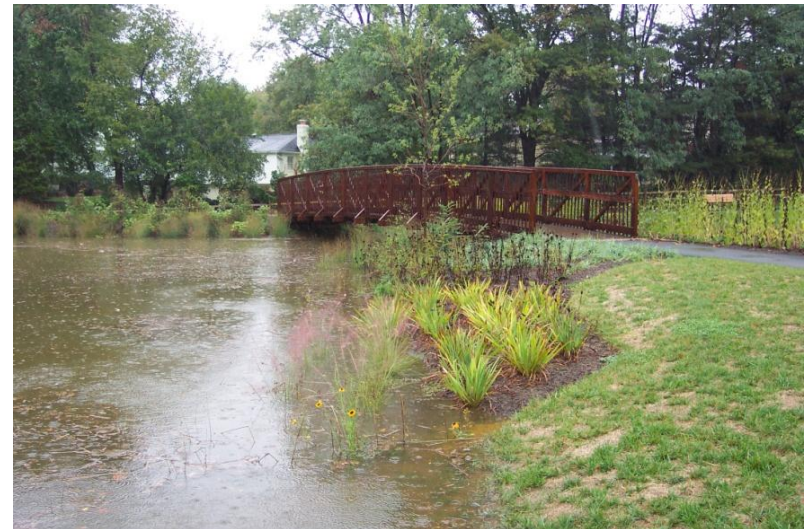
Pond Performance

The new SWM pond during a large storm. It safely manages the diverted runoff without inundating the park decks, plaza or bridge. The fountain rises and falls with fluctuating pond levels.

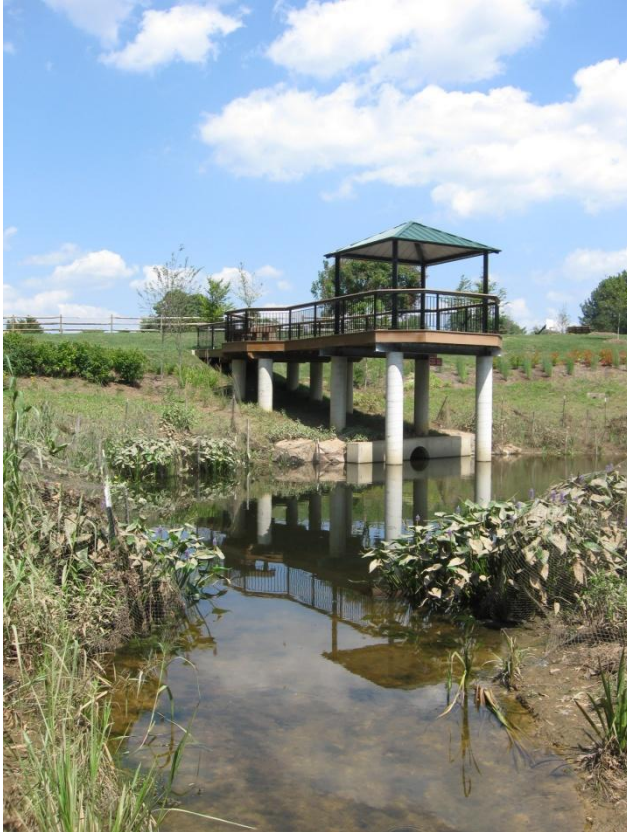
Water enters pond's forebay from a storm drain flow splitter

The New Stormwater Pond: Gained full water quality control and downstream channel erosion protection for the 79-acre drainage area

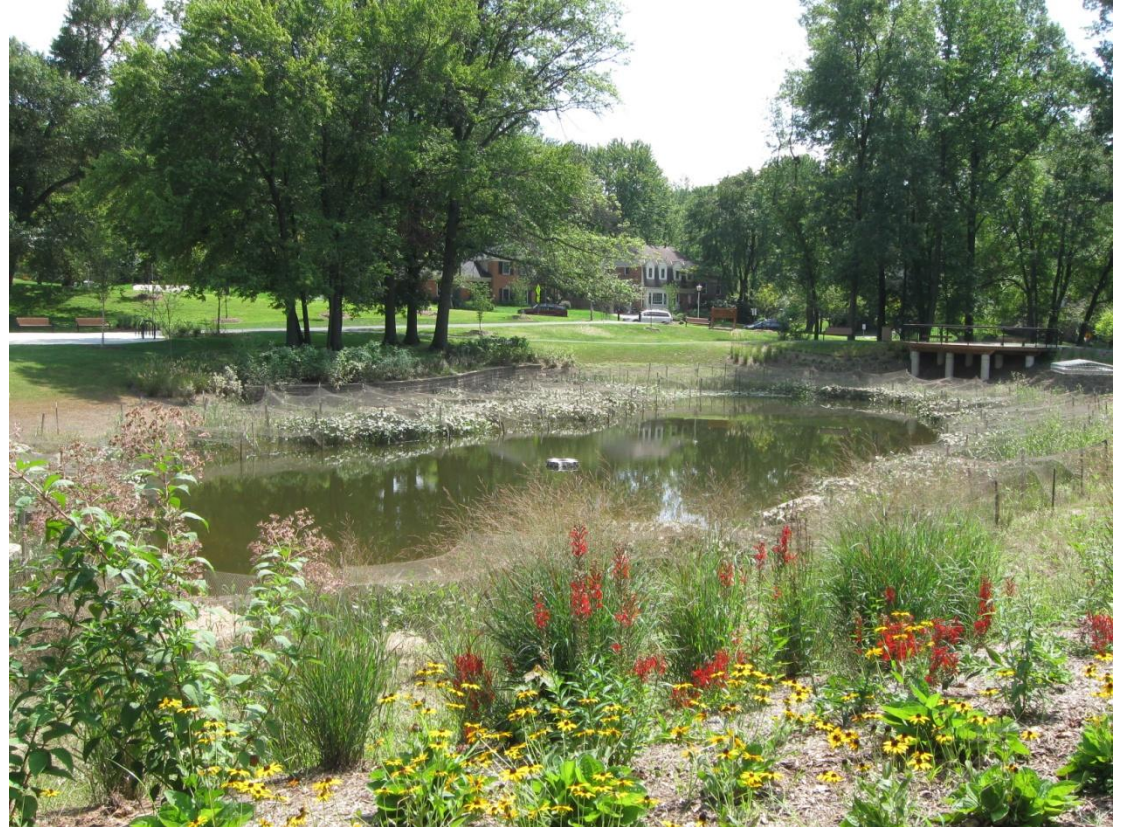
Extensive wetland plantings were protected by goose netting for first year after planting.

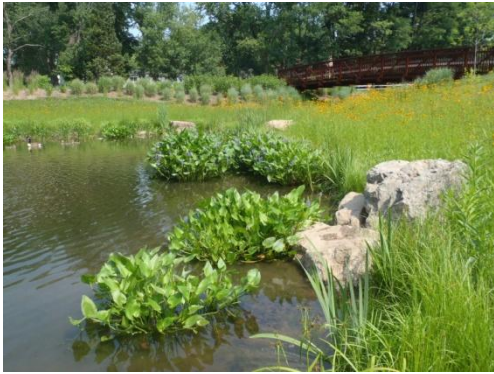
2,400 native wetland plants were installed in the pond

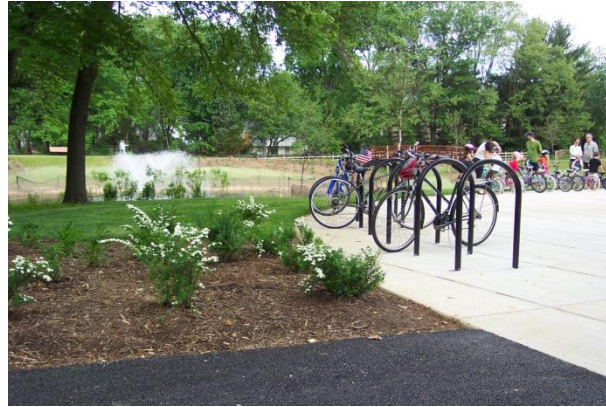
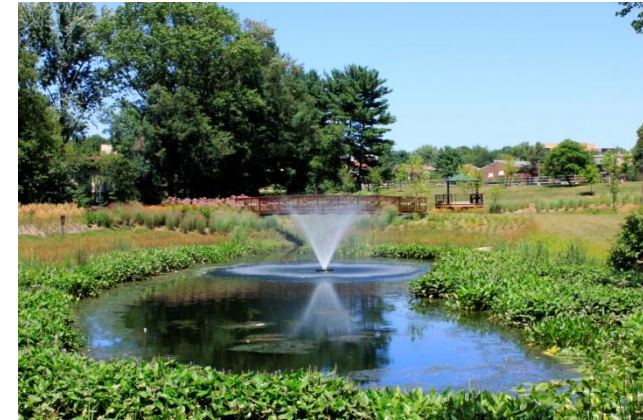
Pond fountain aerates the water and limits mosquitoes
